Two Mile Run Park Master Plan December 2014

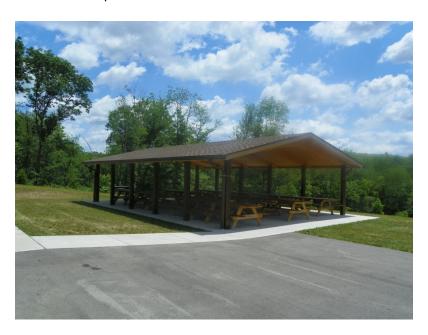
Existing Shelter No. 3

Shelter No. 3 was constructed in 2008 and is therefore in acceptable condition. This shelter was power washed and sealed in 2014.

Date of Construction	2008	
Size	25' x 40' = 1000 sf	
Capacity	Seats 12 x 8 = 96 at picnic tables	
Roofing	Asphalt shingles over pine deck	
Roof structure	Glulam beams	
Roof drainage	Aluminum gutters and downspouts	
Walls/ structure	6"x 8" steel tube columns	
Floors	Concrete slab	
Fixtures		·

Electrical Service	100A panelboard served underground	
	from the lodge. Receptacles on columns	
	and exterior wall pack lighting on beams.	
Mechanical Service	none	
Strengths	New construction, located well above the	
	flood plain.	
Deficiencies

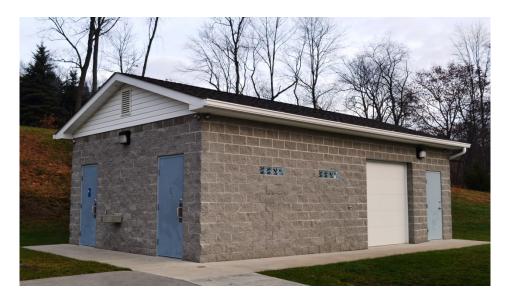
Date of Construction	2010	
Size	20' x 32' = 640 sf	
Capacity	Women: 2 WC = 80 occupants	Based on A-5 occupancy
	Men: 1 WC + 1 urinal = 150 occupants	
Roofing	Asphalt shingles over plywood deck,	
	ventilated aluminum soffit	
Roof structure	Plate-connected wood trusses	
Roof drainage	Aluminum gutters and downspouts	
Walls/ structure	Split-face concrete masonry units, wood-	
	framed gable ends with vinyl siding	
Floors	Concrete slab, painted	
Windows and doors	Glass block windows, steel doors and	
	steel frames, overhead sectional garage	
	door	
Fixtures	Tank toilets, wall-hung lavatories,	
	concrete masonry toilet partitions with	
	steel doors	
Electrical Service	225A panelboard. Interior 4' fluorescent	
	fixtures with wraparound diffusers,	
	exterior wall packs.	
Mechanical Service	15 gallon water heater, exterior drinking	Drinking fountain concrete has
	fountain and hose bibb, exhaust fans,	been broken
	heaters

Strengths	ADA compliant, new construction.	
	Located well above flood plain.	
Deficiencies	Drinking fountains on an accessible route	
	need to be cane-detectable.

Shelter No. 3 Restrooms and Storage Building Recommendations

Replace drinking fountain.	\$2,500
Install railing barrier at drinking fountains	\$300

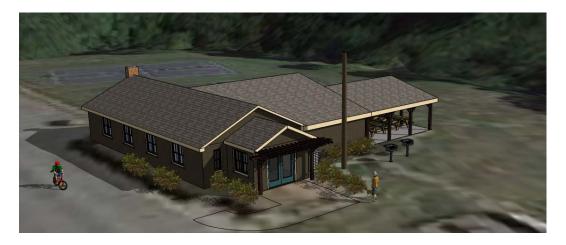
Shultz Lodge Recommendations

exterior lighting	
Mechanical Service	Water heater, furnace, air conditioning,	Problem with uninsulated
The charmear Service	kitchen and toilet room exhaust.	water supply lines to toilet
	Existing toilet rooms each with 1 WC and 1	rooms.
	lav, plus urinal in men's room.	. Tooms.
Strengths	Location convenient to park entrance and

25. 51.851.3	parking. Toilet rooms met ADA when	
	installed and need only minor items for	
	current compliance. Current occupancy	
	certificate.	
Deficiencies	Located in a flood plain.	
Deficiences	Entrance on side of multi-purpose space	
	results in awkward traffic flow.	
	I COUICO III AWKWAIU LIAITIC HOW.

1.	Remove stage area in main room and construct a new entry	\$35,000
	vestibule.	
2.	Remove existing entrance door and infill wall.	\$1,500
3.	Replace windows.	\$3,000
4.	Replace ceiling and lighting fixtures	\$10,000
5.	Replace floor finish with luxury vinyl 'wood' flooring	\$10,000
6.	Add vertical grab bars to existing toilet rooms, for ADA	\$300
7.	Repaint building exterior	\$5,000
	Construction budget:	\$64,800

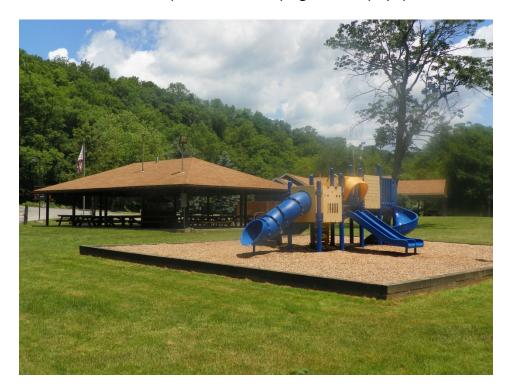
Playground Adjacent to Shelter No. 1 & Shultz Lodge

The existing playground adjacent to shelter 1 is dated and will need to be replaced at a point in the future. We recommend the Township consider developing a natural play space in this area.

Natural play areas rely on natural features serving as the play features. These may include boulders for climbing, natural mounds, 'outdoor rooms' created by planting trees and shrubs, etc. More information on Nature Play can be found here: www.natureplayandlearning.org.

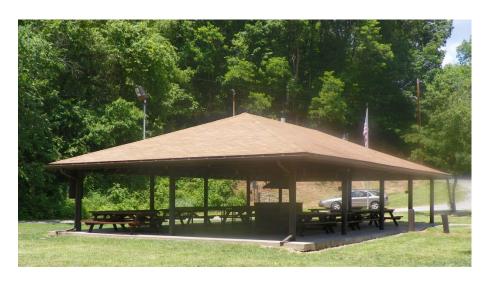
Existing Shelter No. 1

Date of Construction	1964	
Size	27'-6" x 47'-6" = 1306 sf	
Capacity	Seats 12 x 8 = 96 at picnic tables	
Roofing	Asphalt shingles	
Roof structure	Light wood trusses	
Roof drainage	Hanging ogee gutters to downspouts	Downspouts are crushed.
Walls/ structure	Steel pipe columns	
Floors	Concrete slab	
Fixtures	Brick fire pit in center	
Electrical Service	100A panelboard served underground	
	from the lodge. Receptacles on columns	
	and newer "jelly jar" lighting fixtures.	
Mechanical Service	none	
Strengths	Location convenient to park entrance and	
	parking.	
Deficiencies	Located in a flood plain.

Replace downspouts \$250	Replace downspouts	\$250
----------------------------	--------------------	-------

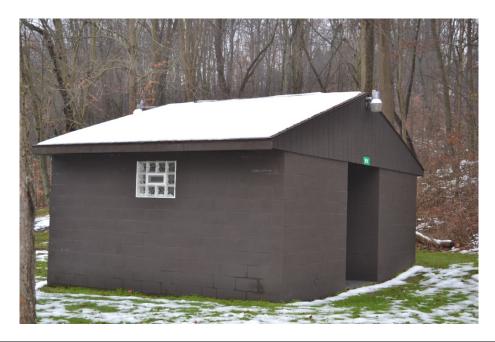
Date of Construction	1987	
Size	16' x 21'-5''' = 343 sf	
Capacity	Women: 2 WC = 80 occupants	Based on A-5 occupancy
	Men: 1 WC + 1 urinal = 150 occupants	
Roofing	Asphalt shingles over plywood deck	
Roof structure	Plate-connected wood trusses	
Roof drainage	No gutters or downspouts	
Walls/ structure	Concrete masonry unit walls with wood	
	framed walls above.	
Floors	Concrete slab, painted	
Windows and doors	Glass block windows with operable vents,	
	newer steel doors and steel frames.	
Fixtures	Tank toilets, wall-hung lavatories,	
	plywood toilet partitions without doors	
Electrical Service	100A panelboard served underground	
	from the lodge. Interior 4' fluorescent	
	fixtures with wraparound diffusers,	
	exterior lighting fixtures	
Mechanical Service	15 gallon water heater, exterior hose	
	bibbs, no exhaust fans	
Strengths	Low maintenance materials. Provides	
	adequate capacity for adjacent pavilion.	
Deficiencies	Does not comply with ADA: entrance,

turning radius, accessible stall size.	
Needs gutters or perimeter splash band.	
Located in a flood plain.

Shelter No. 1 Restrooms Recommendations

Demolish building, replace capacity with new building shared with	
Shelter 2

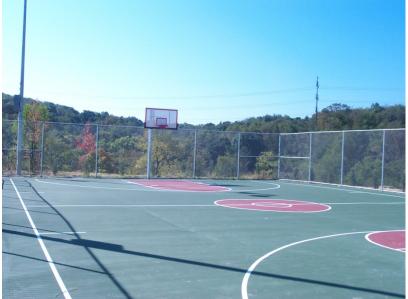
Two existing basketball courts, each 50 feet x 80 feet in size, are located immediately south of the parking lot, and immediately east of Shultz Lodge. The courts are asphalt and they are in fair condition. The asphalt courts have experienced shrinkage cracks which have been repaired. We recommend the Township consider removing the existing courts and re-paving them when other paving work is performed in the park. Further, to increase the aesthetic appeal of the courts we recommend replacing the posts and backboards and color coating the surface of the courts.

Given the rising popularity of hockey, the Township should consider converting one court into a dek hockey court.

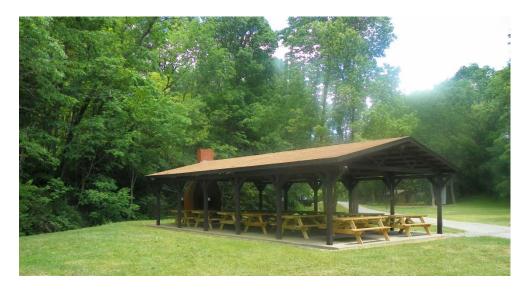
Existing Shelter No. 2

Date of Construction	1974	
Size	23'-2" x 39'-6" = 915 sf	
Capacity	Seats 12 x 8 = 96 at picnic tables	
Roofing	Asphalt shingles over plywood deck	Deck sections are delaminating
Roof structure	Plate-connected wood trusses at columns, 2x4 purlins	
Roof drainage	No gutters or downspouts, perimeter splash band	
Walls/ structure	6" wood posts, braced	
Floors	Concrete slab	
Fixtures	Brick fire place and chimney	Brick needs to be repointed.
Electrical Service	100A panel board served underground from the lodge. Receptacles on columns and newer "jelly jar" lighting fixtures.	
Mechanical Service	none	
Strengths		
Deficiencies	Portions of the roof deck need to be replaced. Located in a flood plain.

Shelter No. 2 Recommendations

Replace deteriorated deck area, ice & water shield, and asphalt	\$700
shingles	
Repoint brick	\$1,000
Rake and restore perimeter splash band	\$1,000
Construction budget:	\$2,700

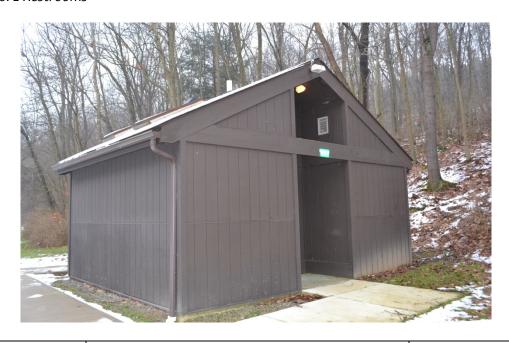
Shelter No. 2 Restrooms

Date of Construction	1972	
Size	16' x 21'-5''' = 343 sf	
Capacity	Women: 2 WC = 80 occupants	Based on A-5 occupancy
	Men: 1 WC + 2 urinal = 225 occupants	
Roofing	Asphalt shingles over plywood deck	
Roof structure	Plate-connected wood trusses	
Roof drainage	Gutters and downspouts.	
Walls/ structure	Wood framed walls with wood siding. Lower half	
	of siding recently replaced.	
Floors	Concrete slab, painted	
Windows and doors	Skylights with security mesh, older steel doors	
	and steel frames.	
Fixtures	Tank toilets, wall-hung lavatories, steel toilet	
	partitions without doors	
Electrical Service	100A panelboard served underground from the	
	lodge. Interior 4' fluorescent fixtures with	
	wraparound diffusers, exterior lighting	
Mechanical Service	15 gallon water heater, exterior hose bibb,	
	exhaust fans, heaters	
Strengths	Provides adequate capacity for adjacent pavilion.	
Deficiencies	Does not comply with ADA: entrance, turning

radius, accessible stall size.	
	Located at toe of a slope and a permanent damp	
	condition has created moisture damage to the	
	siding.	
	Located in a flood plain.

Demolish building, replace capacity with new building shared with
Shelter 1
